Rejuvenating Treatment Preserves Runway, Grooving

Late last year a city-owned airport in California preserved its runway pavements by using a rejuvenating process that also preserved the essential runway grooving.

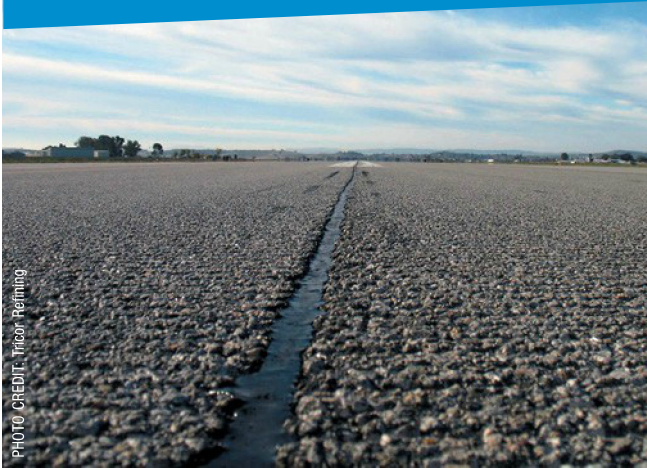
PHOTO CREDIT: Tracor Rejuvening
At Paso Robles Airport, unsealed grooved asphalt was crack-sealed prior to rejuvenator application

In November 2011, in advance of the rejuvenator, longitudinal cracks between paving passes were routed

and filled with Deery 200 Hot Applied Sealant. This work was completed at night.

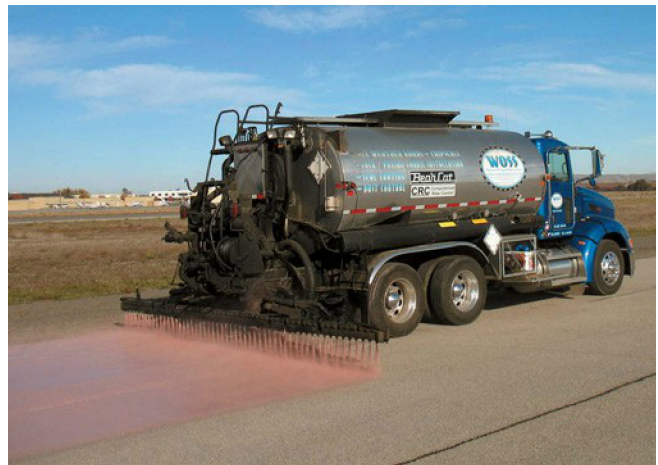
Asphalt pavement rejuvenator is applied to runway by Western Oil Spreading Services

The application of *Reclamite* asphalt rejuvenator was applied the following week. The main concern was the moving target of weather. Although it was late in the year, both the city and the engineering consultant wanted to complete this work. Fortunately the weather pattern was favorable and the rejuvenator seal was applied in one day by the applicator Western Oil Spreading Services, Inc., Santa Paula, Calif.

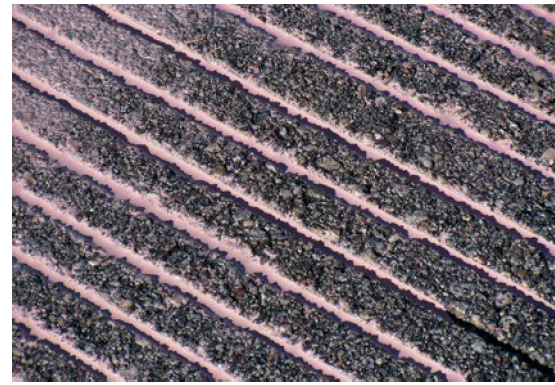
Rejuvenator penetrates asphalt pavement while preserving grooved surface

rate of the rejuvenator at 0.10 gal per square yard of 1:1 diluted emulsion with water. The goal was to maximize surface penetration with little to no surface residual and no sanding or gritting of the surface. This was achieved with rapid absorption of the emulsion.

The challenge was to rejuvenate the asphalt with an emulsion that fully penetrates the asphalt concrete, yet does not plug the voids. The premise of a rejuvenator is to “flux, co-mingle, penetrate” and rejuvenate the asphalt binder, not to add additional asphalt to the pavement, sealing and plugging its surface. The rejuvenator adds back the light oils/ fractions referred to as the maltenes/ saturates that have oxidized from the asphalt binder, causing the aging of the surface.
